**Title:** 18th-20th century flood-induced changes in the landscapes of the Mała Wisła Valley within the Oświęcimska Basin

## **18TH-20TH CENTURY FLOOD-INDUCED CHANGES IN THE LANDSCAPES OF THE MAŁA WISŁA VALLEY WITHIN THE OŚWIĘCIMSKA BASIN**

**Stanisław W. Czaja**

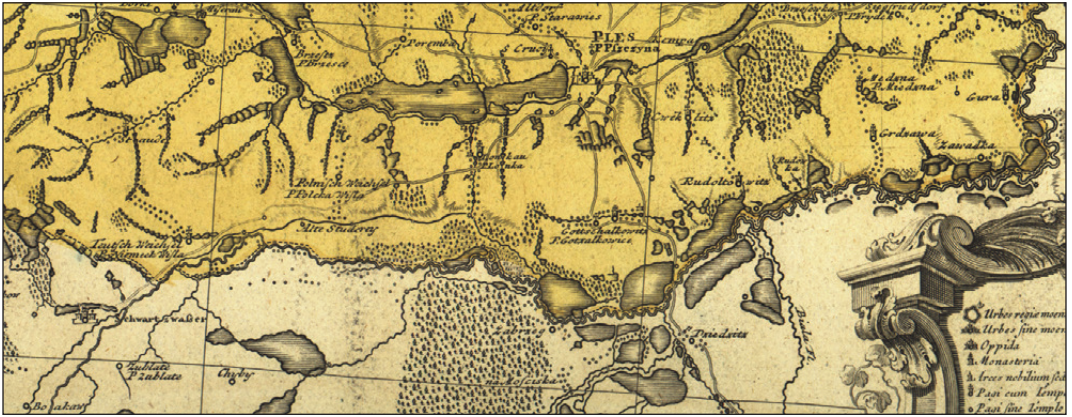
**Figure 1.** The Mała Wisła Valley between Strumień and the confluence with the Biała on the J.W. Wieland map dating from 1736.

Up until the mid 18th century, this area was dominated by primaeval riparian forest that continued to cover as much as 40% of its area (Szweda 2008). Wet meadows in turn constituted 30%, arable land just 15%. The fishponds already referred to as a major landscape element covered almost 14% of the area (Wieland 1736; Czaki 1760; Fig. 1 and 2).

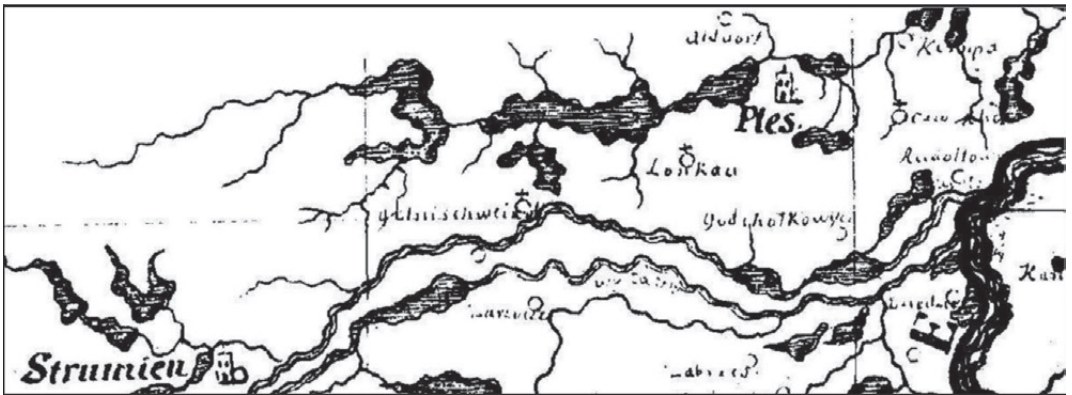
**Figure 2.** The Mała Wisła Valley between Strumień and the confluence with the Biała on the F.F. Czaki map dating from ca. 1760.

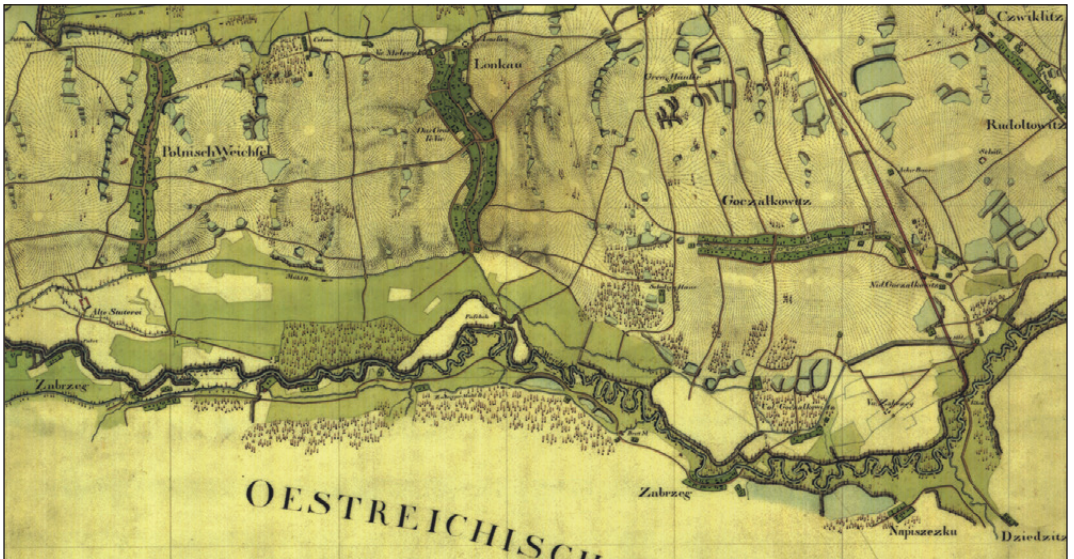
**Figure 3.** The Mała Wisła Valley between Strumień and the confluence with the Biała on the *Urmessstischblätter* map dating from 1823-1831.

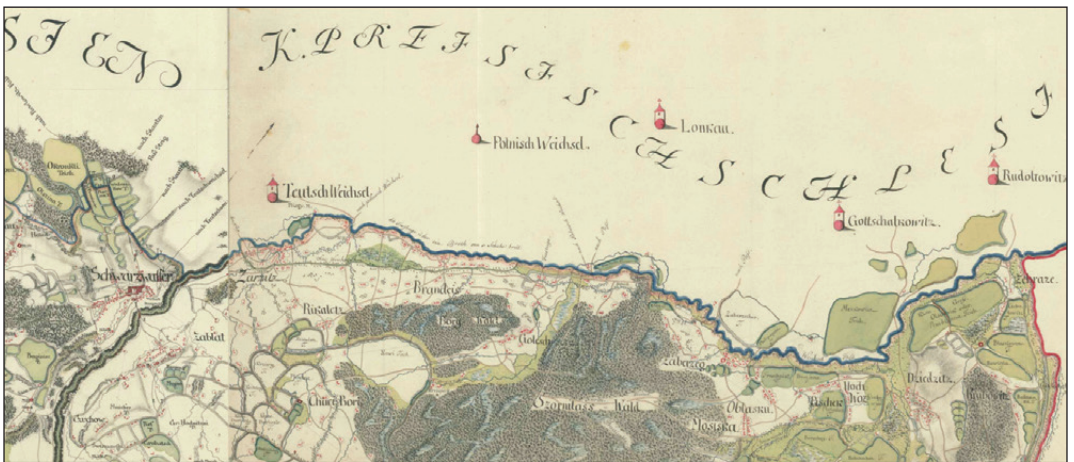
**Figure 4.** The Mała Wisła Valley between Strumień and the confluence with the Biała on the *Kriegs-Charte* map dating from 1763-1780.

create oxbow lakes, or else represent dry troughs some 2-3 m deep. The effect of regulatory work was to lower the erosive base of the river, and hence to encouraging downcutting into the valley floor by even some 1-2 m, as well as the depositing of many elevations that would proved suitable as places to develop settlement. It was on these 'heights' and in the vicinity of stretches of former river channel that large irregularly-shaped multi-road villages came into being. Examples here include Zabrzeg, Zarzecze and Zabłocie, among others (Fig. 4).

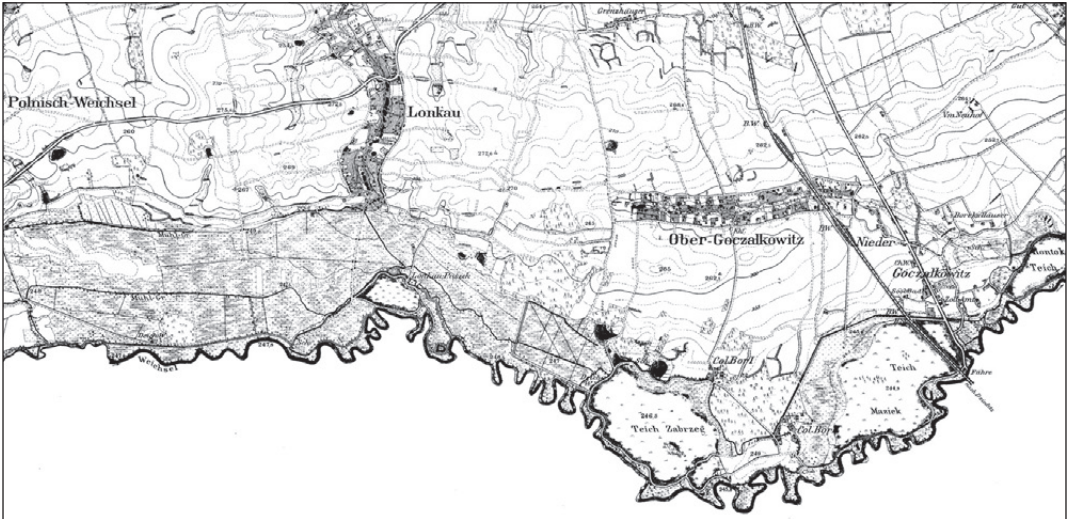
**Figure 5.** The Mała Wisła Valley between Strumień and the confluence with the Biała on the *Messtischblätter* map dating from 1881-1884.

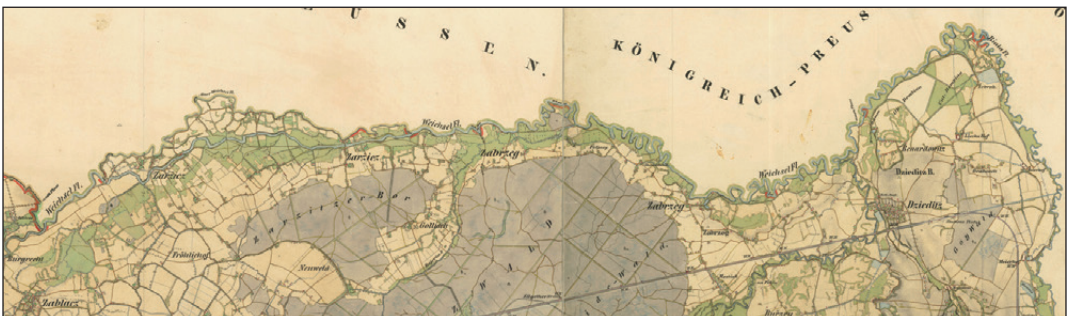
**Figure 6.** The Mała Wisła Valley between Strumień and the confluence with the Biała on the *Übersicht der...* map dating from 1861-1863.
