## Changes in river channel pattern as a result of the construction, operation and decommissioning of watermills – the case of the middle reach of the River Liswarta near Krzepice, Poland

Maria Fajer

### ABSTRACT

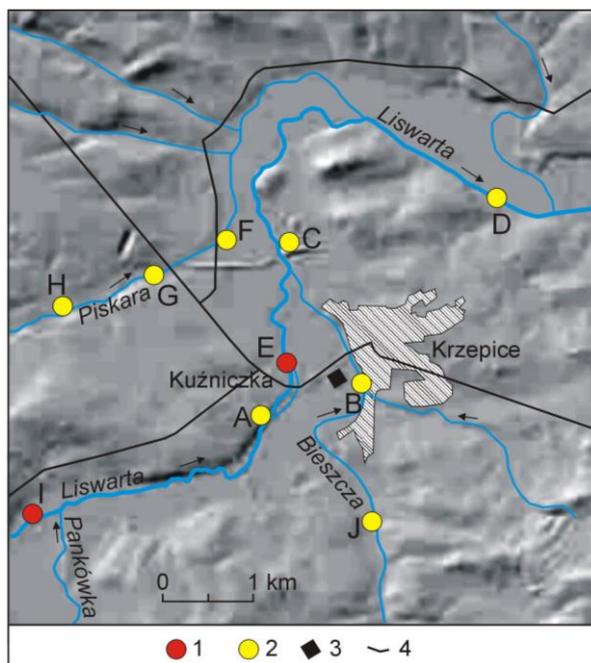
Fig. 1. Locations of the mills analysed

1 – existing mill, 2 – mill no longer exists, located on the basis of archival materials, 3 – castle, 4 – major contemporary roads; Mills: A – Zamkowy, B – Piaskowy, C – Folszowy, D – Magreta, E – Marcelin, F – Drozdkowy, G – Pąchały, H – Siekiery (Lutrowski), I – Starokrzepice, J – Kuków

The study was conducted in the middle reach of the River Liswarta near Krzepice (Fig. 1). This area is located in the Krzepice Depression, which was formed in Middle Jurassic sandy clays and filled

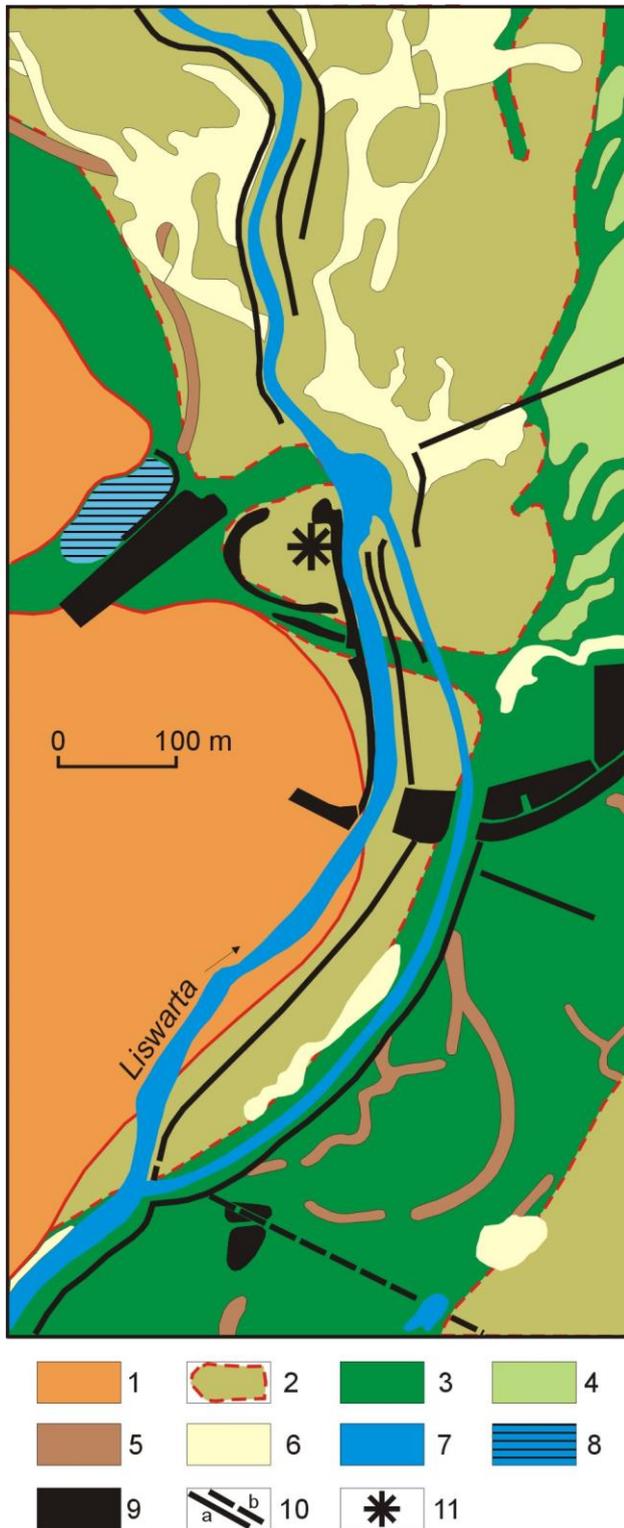
Fig. 2. Geomorphological outline of the left-bank reach of the River Liswarta valley near Krzepice (own research)

1 – plateau, valley floor; 2 – splay and terrace level (late Pleistocene-Holocene); 3 – flood plain; 4 – older bars formed during floods and interchannel islands; 5 – palaeochannels; 6 – younger landforms created by floods (crevasse splays and sand shadows); 7 – flowing and stagnant waters; 8 – pond filled with water in the first half of the 19<sup>th</sup> century; 9 – embankments and artificial terraces; 10 – dykes and levees (a – existing; b – dismantled, marked on old maps); 11 – Marcellin watermill

Near Krzepice, two morphological levels can be discerned in the floor of the River Liswarta valley (Fig. 2), with a difference in relative height of 1–1.5 metres between them. The higher level is present in the western part of the valley floor, nearer to Kuźniczka. It is overlain by flood sediments in the form of crevasse splays and sandy ribbons as well as river channels completely filled with mineral
