Title: The spatio-temporal dynamics of the Ciprnik complex landslide, Tamar Valley, Julian Alps, Slovenia

ANDREJ ŠMUC¹, KAROLINA JANECKA², MICHAŁ LEMPA², RYSZARD J. KACZKA²
(LUBLJANA-SOSNOWIEC)THE SPATIO-TEMPORAL DYNAMICS
OF THE CIPRNIK COMPLEX LANDSLIDE,
TAMAR VALLEY, JULIAN ALPS, SLOVENIA

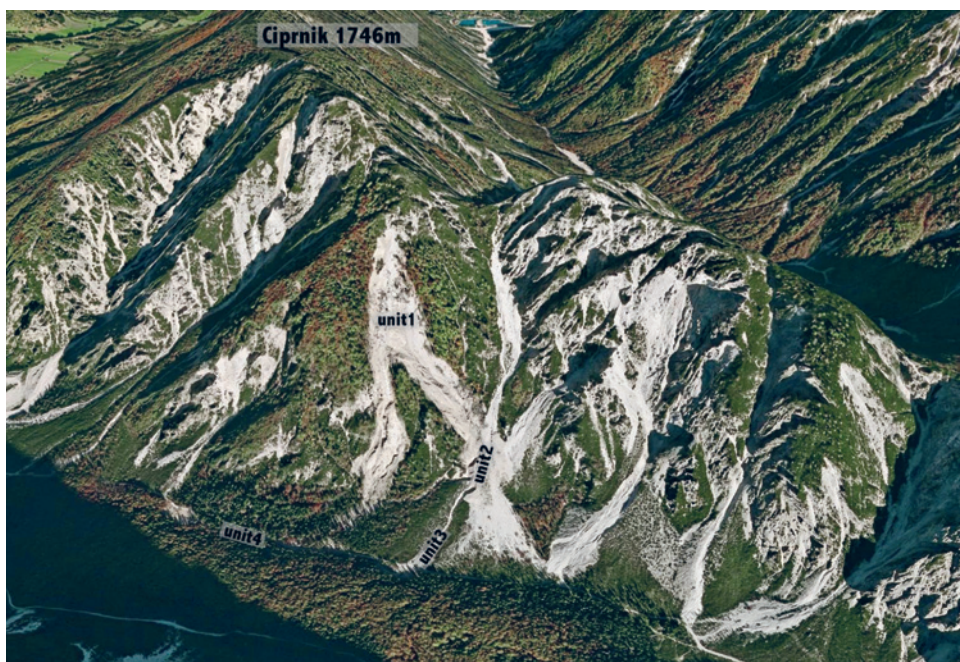
Fig. 1. The study site on W slope of Ciprnik Mt. 1747 m a.s.l., Tamar Valley, Julian Alps

We present a complex landslide Ciprnik from the Tamar Valley, Julian Alps, NW Slovenia. In the night November 18–19 2000 (Jurkovšek 2001), after an exceptionally wet period, a landslide from the lower and middle slopes of the Ciprnik Mountain was triggered (Fig. 1). It flowed into the Tamar Valley as a debris flow, destroyed the road that leads to the Tamar cottage and, after 1 km of travelling towards the lower reaches of the valley, it stopped. Although this event has been reported, detailed research is absent. The Ciprnik landslide (debris flow) is briefly mentioned only in B. Komac and M. Zorn (2007) and B. Komac et al. (2009) where a general description and surface area of the landslide were approximated. In this article we try to fill this gap and present the spatio-temporal dynamics of the complex Ciprnik landslide and interpret its triggering conditions.

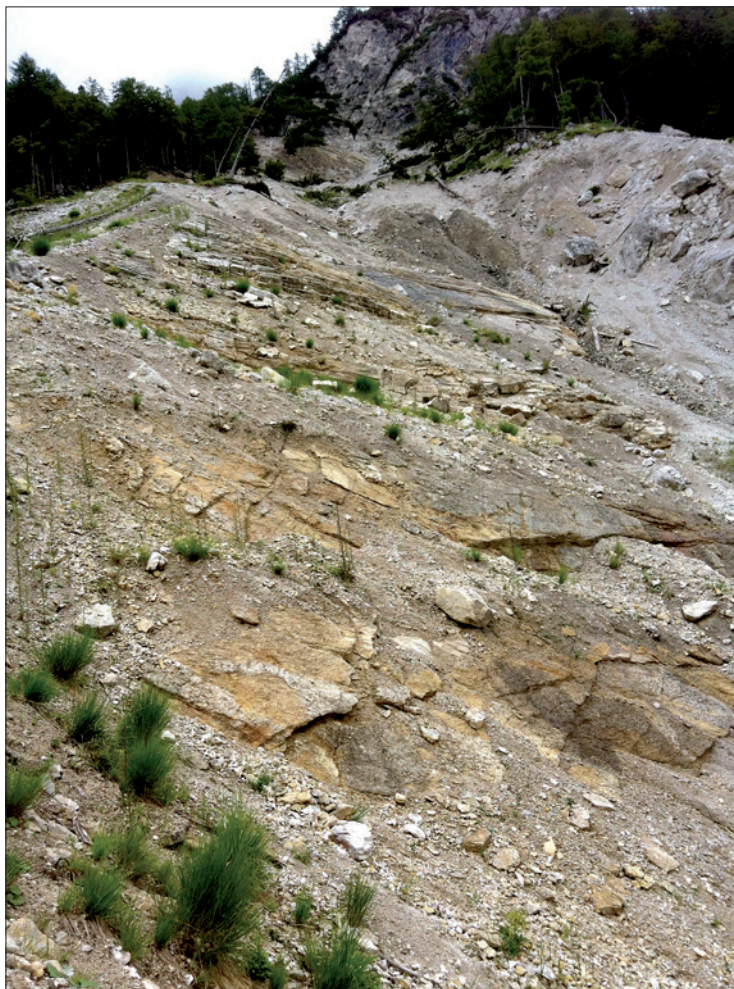
Fig. 8. Catchment area of the Ciprnik complex landslide (Unit 1 of Fig. 7)

Unit 1 represents the catchment area for the landslide and extends from approximately 1500 m to 1130 m a.s.l., covering an area of around 80,000 m² (Fig. 8). The area is composed of the strongly faulted Tor Formation underlain by faulted Cozen dolomites (Gale et al. 2015). Cozen dolomites are poorly bedded to massive dolomites (bed thickness ranges from decimetre to metre scale) characterised by alternating lime mudstones, fenestral dolomites and stromatolitic and oncoidal dolomites (Gale et al. 2015). The Tor Formation consists of thin to medium-bedded (bed thickness ranges from a few cm to a few 10s cm) alternation of carbonate beds (i.e. limestones, dolomites, marly limestones) and fine-grained clastics (siltstone, claystone and marlstone: Gale et al. 2015). The dip of the beds ranges from 25–40° generally towards the south. The slip plane of landslide is clearly visible in Unit 1 (Figs. 7 and 8). In Unit 1, some loose “left over” debris of very poorly sorted, muddy sandy gravels is also present. Gravel clasts belong to the Tor Formation exclusively.

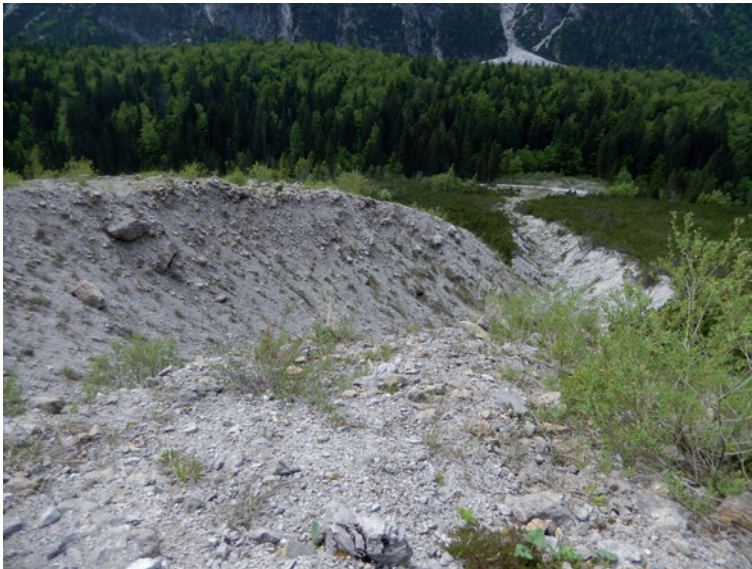
Fig. 10. Erosional channel eroded into older debris of Unit 2 (left on the picture) and fluvial fan deposits (Unit 3A of Fig. 7). View downwards

Unit 3 is eroded into deposits of Unit 2 (Figs. 7 and 10). The upper part (Unit 3A) is represented by a partly filled up (to a few metres deep and wide) erosional channel that extends from approximately 1150 m to 1073 m in altitude. The lower part of Unit 3 (Unit 3B) is represented by a fan-shaped body composed of a depositional sequence of poorly sorted muddy gravels in the upper reaches of the fan, while the clasts are finer at the fan end. The clasts are composed of Cozen dolomites and lithologies of the Tor Formation.

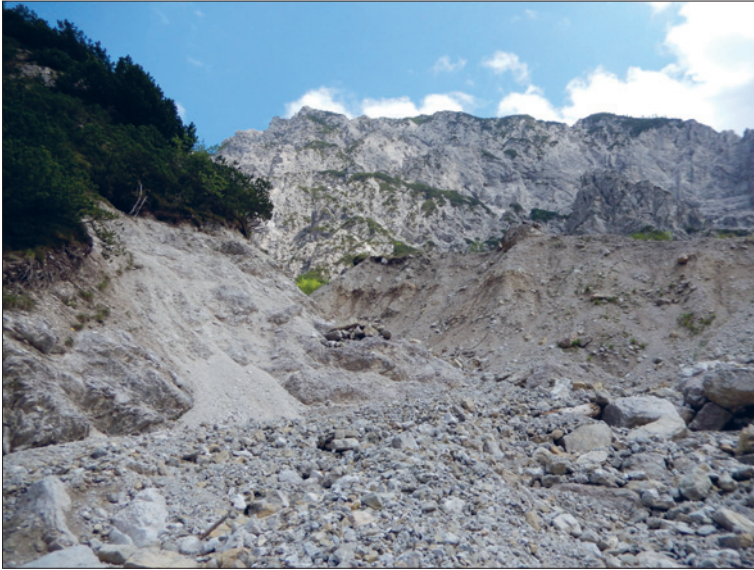
Fig. 11. Erosional channel cut into contact of bedrock (left on the picture) and older mass deposits (Unit 4A of Fig. 7)

Unit 3. Unit 4 is further divided into three distinct units (Unit 4 A–C: Fig. 7). Unit 4A is a mainly erosional feature characterised by up to a few 10s of metres wide and around 270 m long erosional channel extending from 1130 m to 1060 m in altitude (Fig. 11). The channel is cut into bedrock or into older deposits (i.e. alluvial fan deposits and older debris flow deposits of Units 2 and 3) and is partly filled by poorly sorted muddy gravels, ranging from cm-sized pebbles to

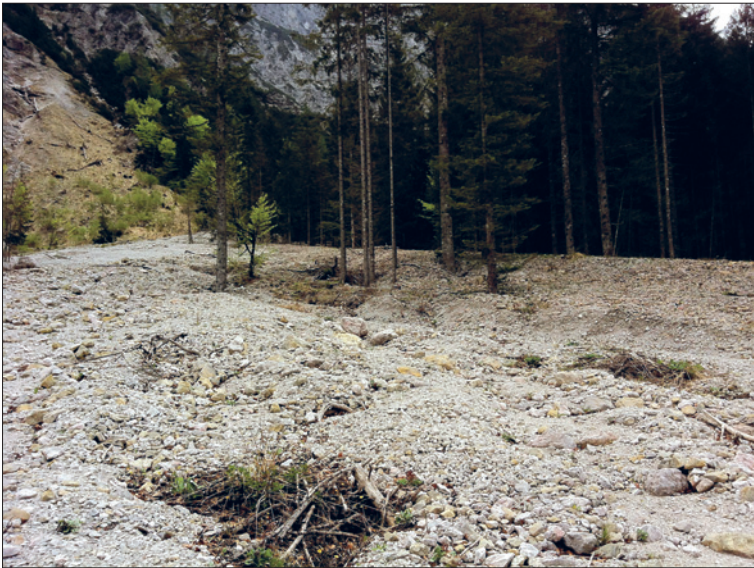
Fig. 12. Upper part of the fan-shaped body (Unit 4B of Fig. 7)

sequence of poorly-sorted coarse-grained sediments forming a 470 m long and up to 140 m wide fan-like shaped sedimentary body (Figs. 7 and 12). Unit 4B extends from 1060 m to 1013 m a.s.l.. Down the fan is progressively wider; similarly the slope of the fan decreases from 20° in the upper part to the 5° in the lower reaches of middle part. The grain size of the sediments ranges from poorly to very poorly sorted muddy sandy gravels. The transition from middle to lower part of the fan is gradual and characterised by an increase in finer-grained components. The clasts belong to Cozen dolomites and Tor Formation lithologies. Unit 4C represents the terminal part of the flow fan and is characterised only by a sand to mud fraction forming so-called “mud lake”, located at 1013 m altitude (Figs. 7 and 13).

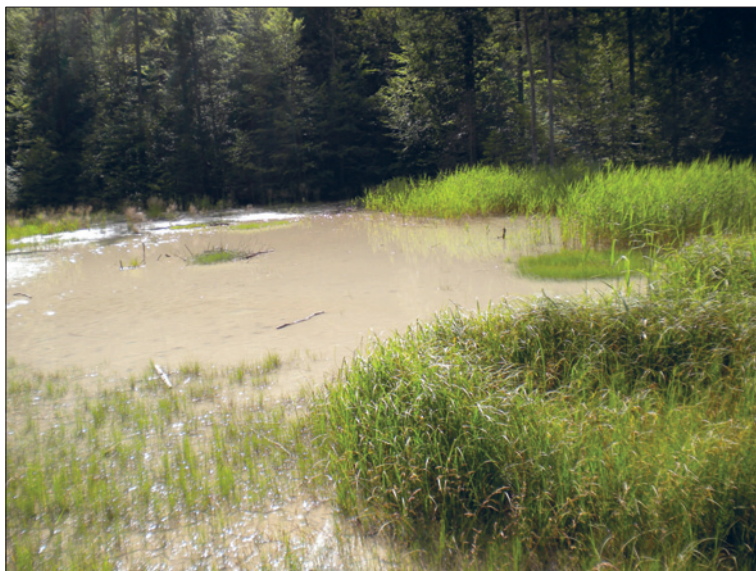
Fig. 13. “Mud lake” at the end of the Unit 4 of the Ciprnik complex landslide (Unit 4C of Fig. 7)
