Title: Dendritic structure analysis of CMSX-4 cored turbine blades roots

Author: Jacek Krawczyk

DENDRITIC STRUCTURE ANALYSIS OF CMSX-4 CORED TURBINE BLADES ROOTS

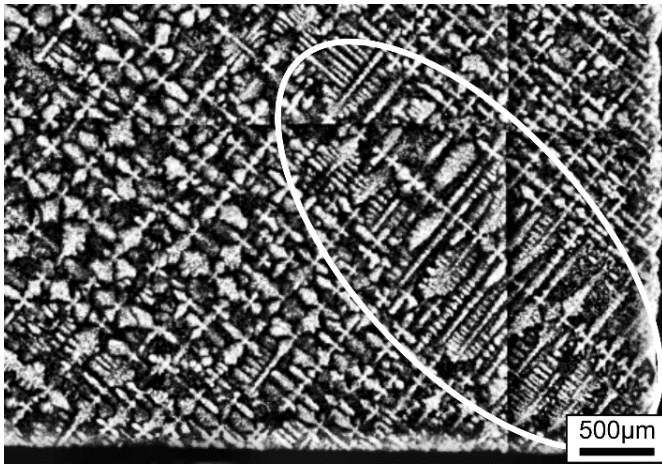
Fig. 8. SEM micrograph (BSE technique) of the blade root dendritic structure in area 4 (Fig. 3)

The fragment of microstructure shown in Fig. 8 and marked by an ellipsis is characterized by a very high elongation of dendrite arms (primary arms). They have a shape of long, thin rods. Additionally, in the areas of excessive growth of dendrite primary arms the growth of secondary arms is visible. Secondary dendrite arms have a needle-like shape and are densely arranged on the primary dendrite arms. This type of structure is often found near the corner areas of samples and in some areas around the cooling bores. When the distance from the edge of roots is higher, the dendritic structure is more ordered. The dendrite arms (primary arms) become more regular and the growth of secondary dendrite arms is blocked.
