Proceedings of the XXIII Conference on Applied Crystallography, Krynica Zdrój, Poland, September 20–24, 2015

Analysis of CMSX-4 Single-Crystalline Turbine Blades Root by Electron and X-Ray Diffraction Methods

The root of single-crystalline turbine blade made of CMSX-4 superalloy were studied. The studied blade was produced by the Bridgman technique in industrial ALD furnace at withdrawal rate of 3 mm/min. The samples for investigations were cut from the blade root parallel to the withdrawal direction. Metallographic sections of longitudinal samples planes were prepared for further investigations. The samples were analysed using scanning electron microscopy and the Laue diffraction studies. The crystal orientations in macro-scale were determined by analysis of the Laue pattern and local crystal orientations were studied by electron backscattered diffraction technique. Morphology of dendrites were examined by analysis of scanning electron microscopy macro-images. Study of subgrain structure was performed by X-ray diffraction topography. The sharp parallel contrast bands, visible on the X-ray topograms, were related with dendrite cores, arranged with the same direction. Additionally

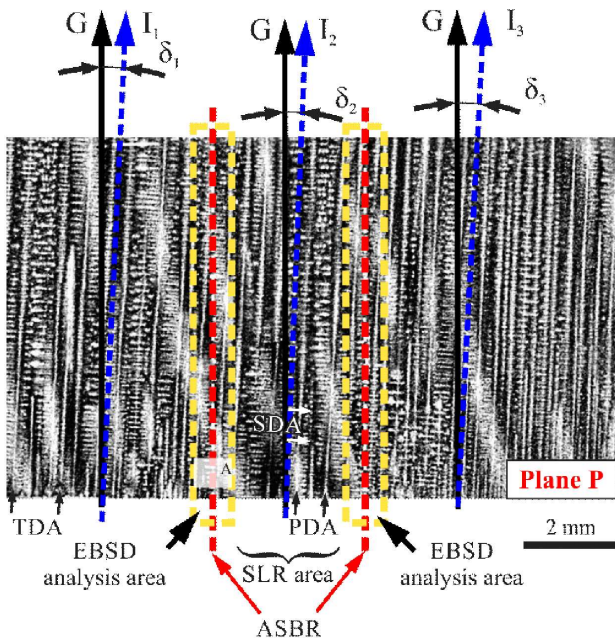
Fig. 2. Example of SEM macro-image fragment, obtained from plane P. SLR — selector area, ASBR — approximate subgrain boundary regime, G — withdrawal direction, I_1 , I_2 , I_3 — directions of dendrite cores, PDA — primary dendrite arms, SDA — secondary dendrite arms, TDA — ternary dendrite arms.

Figure 2 shows typical structure of as cast CMSX-4 superalloy in longitudinal cross-section. There are visible three regions containing dendrites with co-directional cores (direction I_1 , I_2 and I_3), inclined to the direction G at an δ_1 , δ_2 or δ_3 angle (Fig. 2). Determined angle values are: $\delta_1 = 2.7^\circ$, $\delta_2 = 2.4^\circ$, and $\delta_3 = 3.2^\circ$. The centre of analysed surfaces is situated above the blade selector and marked as SLR (selector) area (Fig. 2). In SLR area the dendrites cores grow directly from the selector along direction I_2 . The dendrites with evenly spaced arms have regular shape and fixed size. Excepting the SLR area, the dendrite cores, visible in Fig. 2, form tertiary arms. At the final part of the selector, where the blades root begins to crystallize, secondary dendrite arms grow almost horizontally toward the mould sidewall, forming a base for tertiary dendrite arms growth. There are irregularities in arrangement of dendrites and differences in the size and shape of its arms in areas except the SLR. Estimated value of δ_1 and δ_3 angles are higher than estimated value of δ_2 angle.

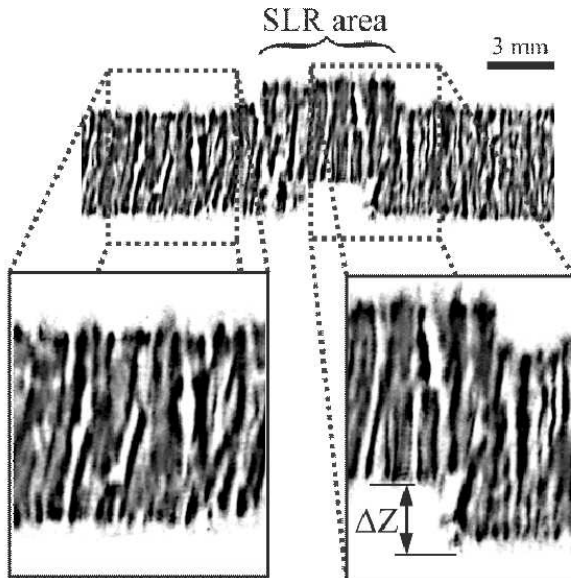
Fig. 5. Typical X-ray topogram obtained with sample oscillation. 220 reflection, $\text{Cu } K_\alpha$ radiation, ΔZ — shift that describes subgrain misorientation.

Figure 5 shows typical X-ray topogram, obtained from P-type plane (Fig. 2). There are visible three main separate contrast areas with different mutual arrangement. Central area of the presented topogram corresponds to selector area (SLR area — Fig. 2). The contrast bands, visible on the topogram are arranged in particular areas parallel to directions I_1 , I_2 and I_3 (Fig. 2), respectively. There are visible shifts between neighbouring contrast areas, exemplary selected and marked on the topogram as ΔZ (Fig. 5, right inset). ΔZ value describes subgrain misorientation angle [7]. Misorientation angle, defined for presented topogram is about 3° . Similar ΔZ shifts occur at all obtained topograms. Additionally, the right edge of SLR area is covered by neighbouring contrast area. Contrast on the edges of these areas is higher than beyond.

The sharp parallel contrast bands, visible on the X-ray topograms, are related to dendrite cores arranged with the same direction. Inclination of dendrite cores to the withdrawal direction in particular areas of the samples

is different. The shifts of contrast areas indicate occurrence of low angle boundaries, formed in certain samples. Various crystal orientation in neighbouring sample areas, defined by EBSD analysis, confirm subgrains occurrence. Additionally, EBSD orientation maps allow to determine subgrain boundary trace. The boundary passes through dendrites and interdendritic regions.
